## **FACE INVESTIGATION**

**SUBJECT: Crew leader crushed when forklift load carrier falls from forklift**

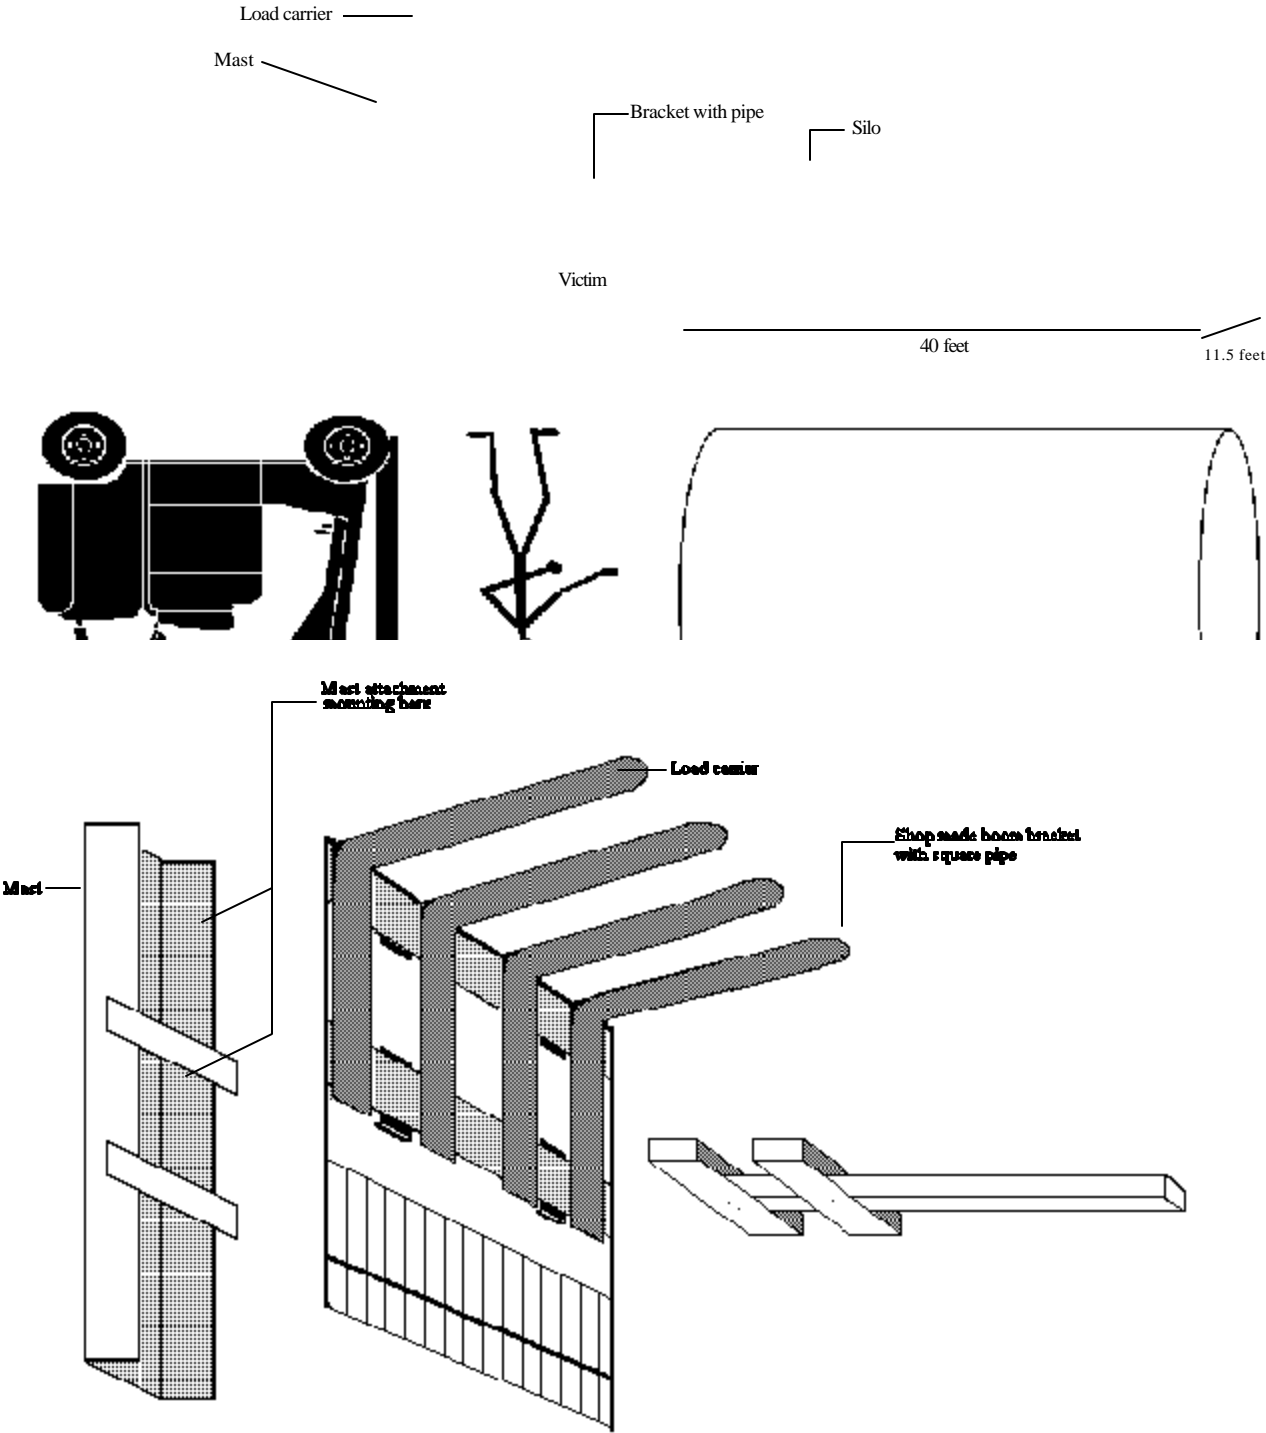
Figure 1

Discussion: The forklift in this incident was equipped with a load carrier and shopmade bracket with lifting pipe that had not been approved for use by the forklift manufacturer. The additional and modified equipment may not have been secured firmly enough to the forklift to hold the lifting equipment and load. The OSHA standards 29 CFR 1910.178(a)(4) and 1910.178(q)(6) require manufacturer approval before modifications or additions are made to industrial trucks.

**Recommendation #2: Employers should obtain and follow forklift manufacturers' recommendations for attaching and using modified equipment.**
